Manhole Inspection Summary

Manhole # S29UU1017MH

Location Address: **200 WYNDHURST AVE**

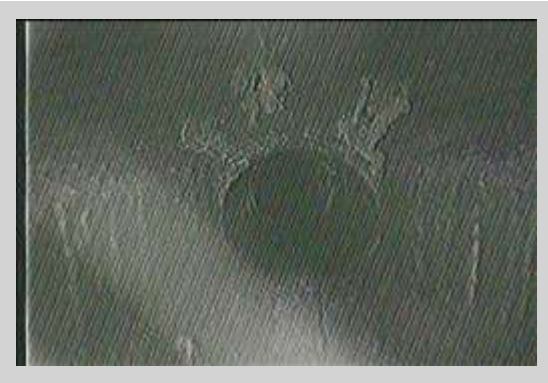
8 in. Circular Gravity Sewer Pipe Out @ 12 O'Clock

Pipe Material: **Clay** ☐ Pipe Lined

Invert Depth: **6.84** (ft.) Flow Characteristics: **None**

Deposits: ☒ None ☐ Mud ☐ Sludge ☐ Debris ☐ Grease

Infiltration: **None** Pipe Seal Cond: **Unknown**

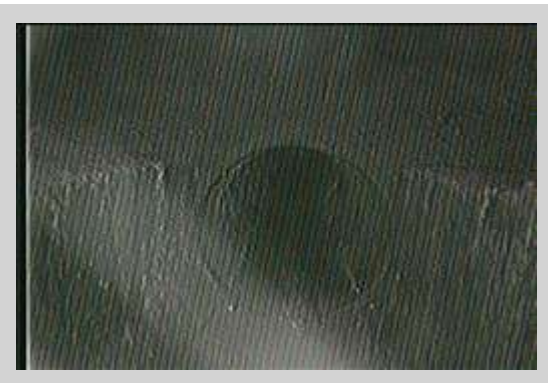
8 in. Circular Gravity Sewer Pipe In @ 6 O'Clock

Pipe Material: **Clay** ☐ Pipe Lined

Infiltration: **None** Pipe Seal Cond: **Unknown**
